**DEPARTMENT OF TRANSPORTATION**

Contract #: 04-0120F4Cty: SF/ALA Rte: 80 PM: 13.2/13.9File #: 1.28**WELDING INSPECTION REPORT****Resident Engineer:** Casey, William**Address:** 333 Burma Road**City:** Oakland, CA 94607**Report No:** WIR-029923**Date Inspected:** 17-Aug-2013**Project Name:** SAS Superstructure**OSM Arrival Time:** 700**Prime Contractor:** American Bridge/Fluor Enterprises, a JV**OSM Departure Time:** 1530**Contractor:** American Bridge/Fluor Enterprises, a JV**Location:** Job Site**CWI Name:** Bernie Docena, Jesse Cayabyab**CWI Present:** Yes No**Inspected CWI report:** Yes No N/A**Rod Oven in Use:** Yes No N/A**Electrode to specification:** Yes No N/A**Weld Procedures Followed:** Yes No N/A**Qualified Welders:** Yes No N/A**Verified Joint Fit-up:** Yes No N/A**Approved Drawings:** Yes No N/A**Approved WPS:** Yes No N/A**Delayed / Cancelled:** Yes No N/A**Bridge No:** 34-0006**Component:** SAS Tower**Summary of Items Observed:**

**NDT Inspection of Electroslag Welds (ESW)**

**ESW Repair excavation**

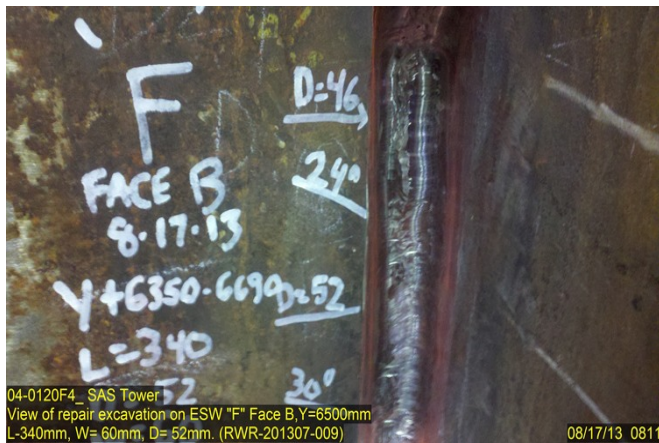
“F” Face B @ Y-6470mm to verify indications observed during Ultrasonic Testing pulse/echo & pitch/catch. Mr. Lai was performing air carbon arc gouging and grinding on the excavation. After grinding to bright metal the ABF QC Inspector Bernie Docena performed MT testing of the excavation. Details of the final repair excavation are as follows:

WeId excavated at 52mm-No indications observed.

Excavation Length (Y=6350mm~6690mm) L=340mm, W= 60mm, D= 52mm.

The QC Inspector stated the excavation appears to be free of discontinuities and he would complete ABF daily inspection report and magnetic particle testing report to detail the findings. The QA Inspector also performed MT inspection of the final excavation. After excavation Mr. Lai set up to perform SMAW repair welding on this date. See TL-6028 for additional details on items inspected on this date.
